FINAL REPORT

Ecological Asset Review

First Unitarian Church

Report No. 1 2100557.ON

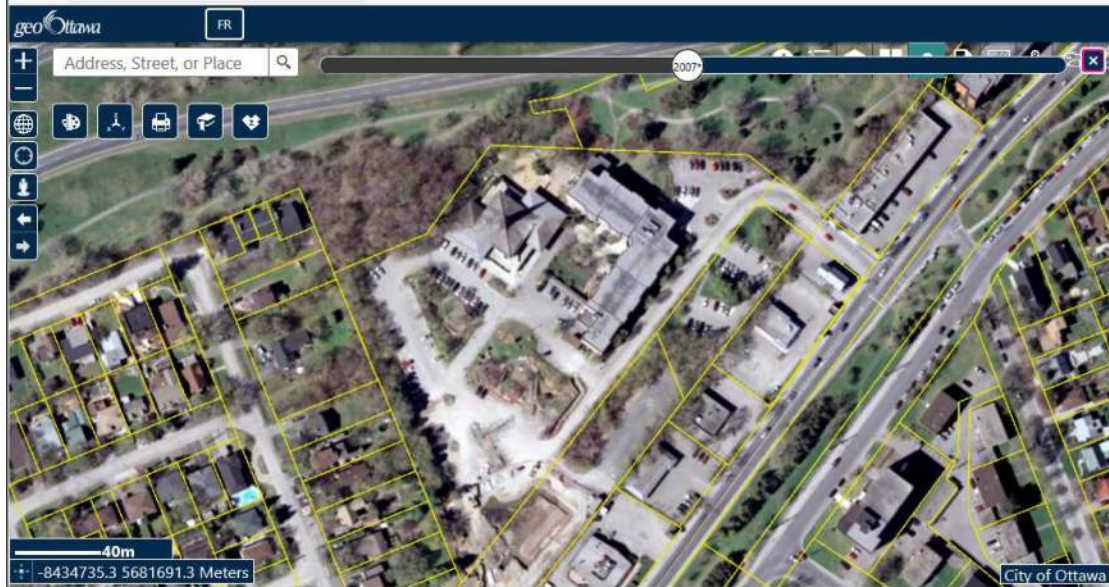
Figure 6: First Unitarian Church Property Aerial Image from 2007; image from GeoOttawa, 2020.

The tree cover that existed in the 1970's was slowly replaced, particularly in central parts of the property, with younger trees. Between 2005 and 2007, an addition parking lot was established in what was formerly an old rail bed and the River Parkway Childcare Centre was under development (refer to **Figure 6**). Within the two garden areas and the courtyard, trees and other vegetation were maturing.

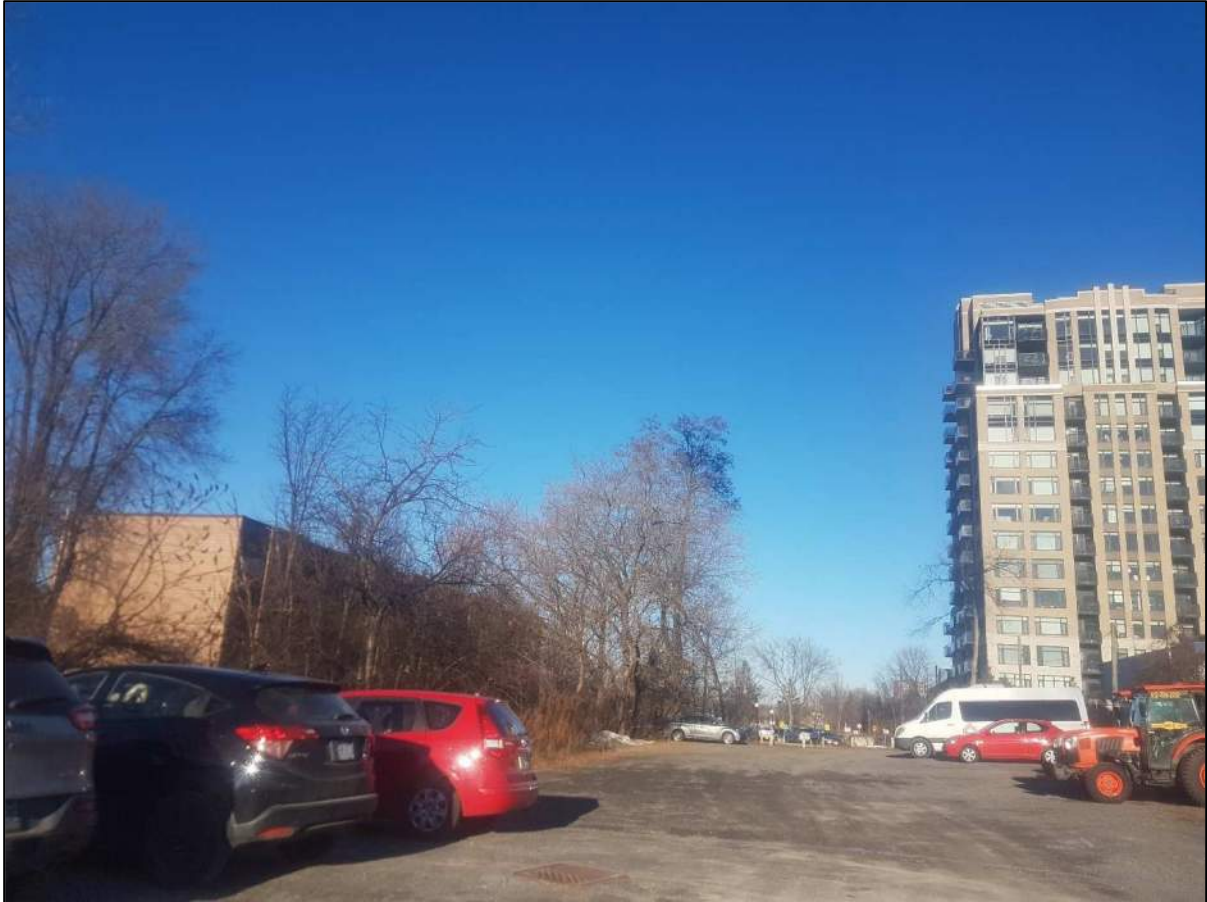
Based on this review, the area containing the old rail line ballast (refer to **Figure 8** below), currently used as a parking lot, is likely underlain with gravel and may contain contaminated soils from chemicals used to treat railroad ties such as creosote; spilled or leaked liquids such as oil, gasoline, cleaning solvents; herbicides; and fossil fuel combustion products (PAHs). An Environmental Site Assessment is recommended in order to determine the actual presence of contamination. Restoration in the former rail line area will impose challenges due to the ballast materials and due to possible soil pollutants. The proposed use for the development of high-rise buildings is appropriate given the challenges with restoring natural habitat in this area. As well, parking could be retained in underground or above-ground parking levels within the buildings.

Figure 8: Old Rail Line area, photo taken November 12, 2020.

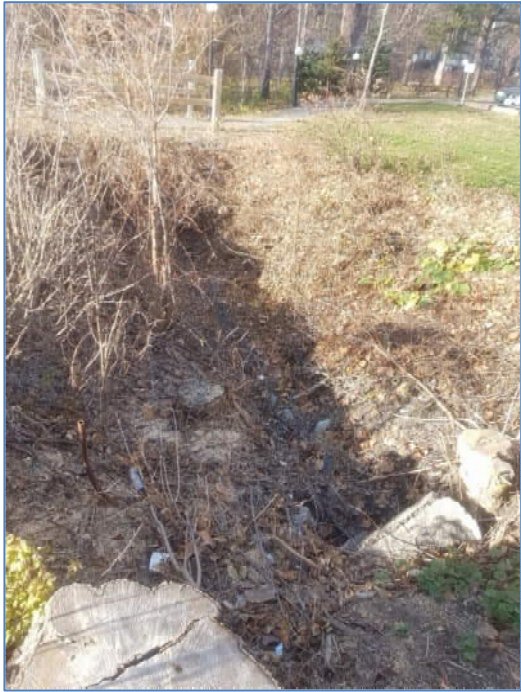
Figure 10: Upstream portion of the first surface drainage feature, at south central part of the property, coming from between the parking lots on the Old Rail Line area; photo taken November 12, 2020.

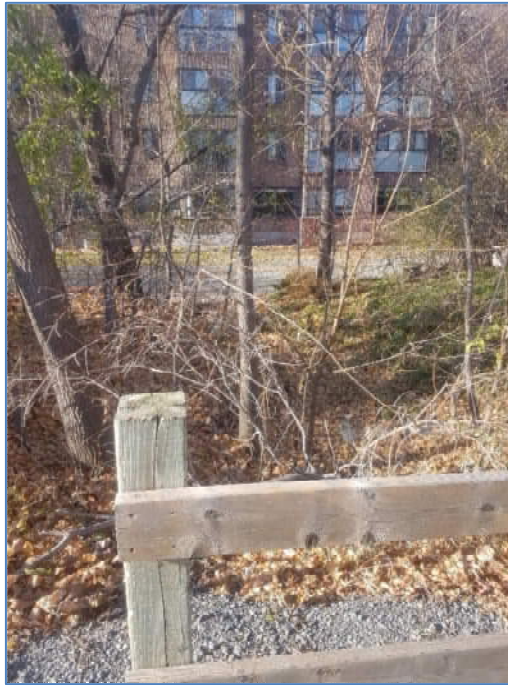
Figure 11: Downstream portion of the first surface drainage feature, south of the Unitarian House, facing north; photo taken November 12, 2020.

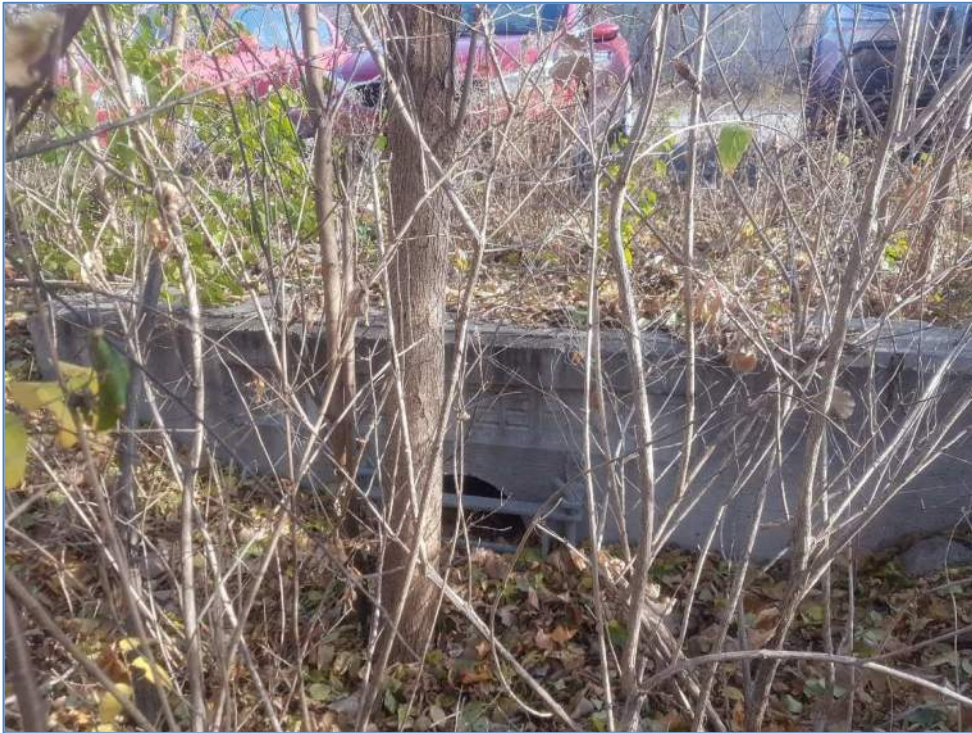
Figure 13: Upstream portion of the watercourse, located below the parking lots on the Old Rail Line area; photo taken November 12, 2020.

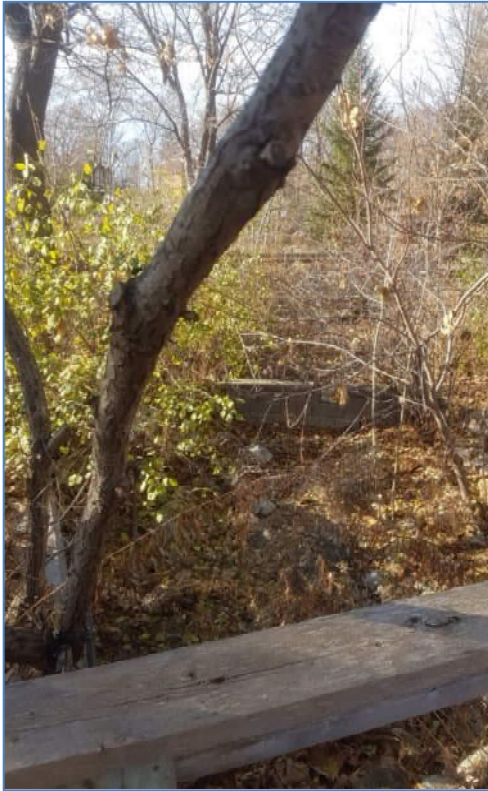
Figure 15: View of semi-permanent watercourse and weir from within the Memorial Garden; photo taken November 12, 2020.

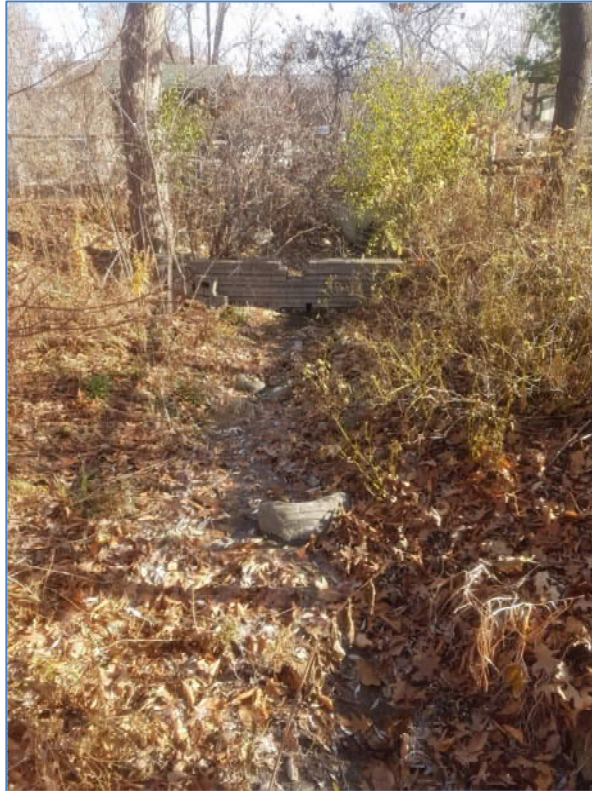
Figure 16: View of semi-permanent watercourse and another downstream weir from within the Memorial Garden; photo taken November 12, 2020.

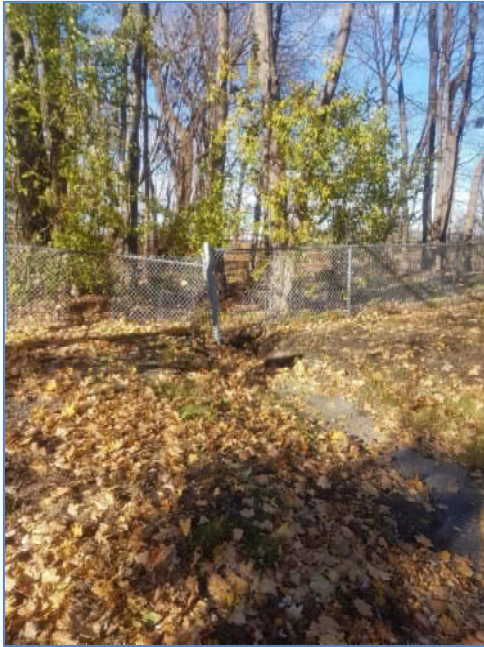
Figure 18: Downstream end of watercourse, where it connects to the watercourse within the NCC property; photo taken November 12, 2020.

A more semi-permanent stream (Watercourse in **Figure 9**) starts from within the property from a culvert located on the treed slope along the north side of the old rail line (refer to photo in **Figure 13**). This then flows under the driveway, through the southern Memorial Garden (refer to photos in **Figure 14**, **Figure 15**, and **Figure 16**), under another lane, into the northern triangular Meditation Garden (refer to photo in **Figure 17**), and finally exits into the drainage feature on the adjacent NCC property (refer to photo **Figure 18**), that flows into the Ottawa River to the north.

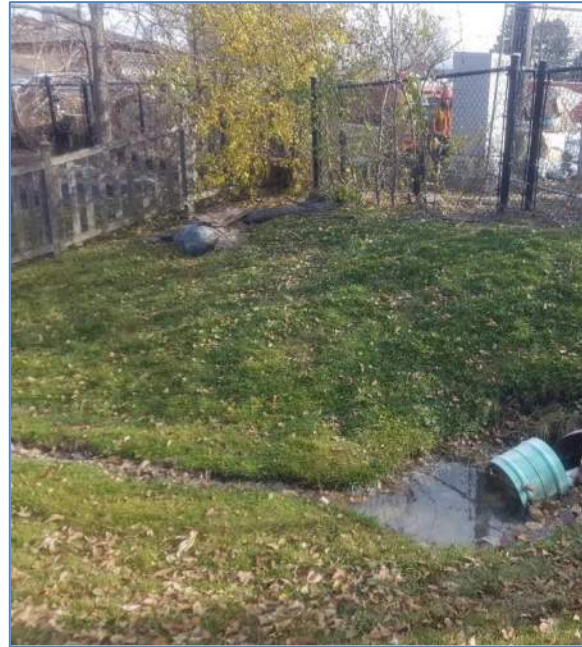
Figure 19: Downstream end of culvert and source of the second surface drainage feature, at southwest corner of the River Parkway Childcare Centre's playground; photo taken November 12, 2020.

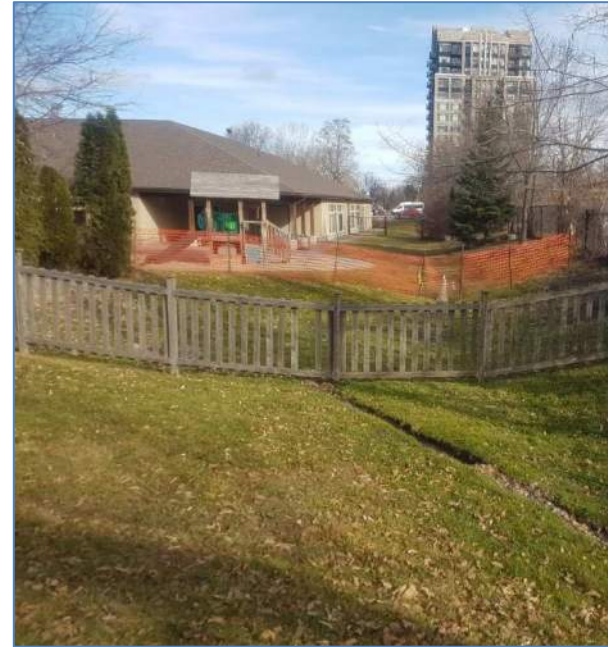
Figure 20: The second surface drainage feature downstream of the end of the culverts, south of the River Parkway Childcare Centre's playground; photo taken November 12, 2020.

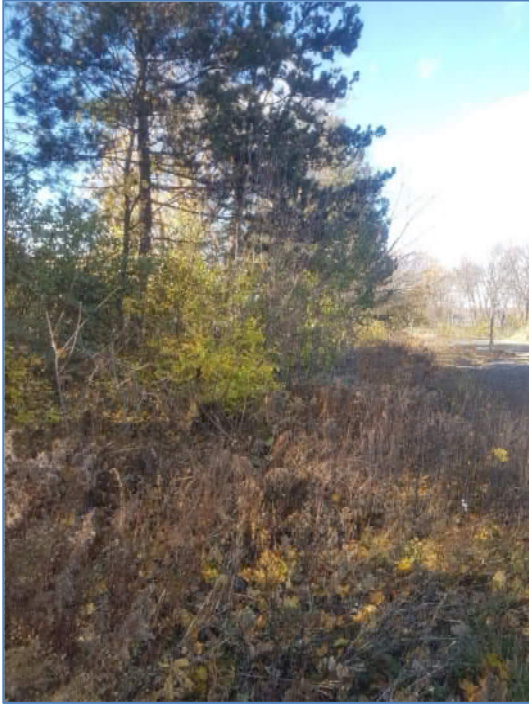
Figure 21: Upstream portion of third surface drainage feature on the west side of the property, from near the River Parkway Childcare Centre; photo taken November 12, 2020.

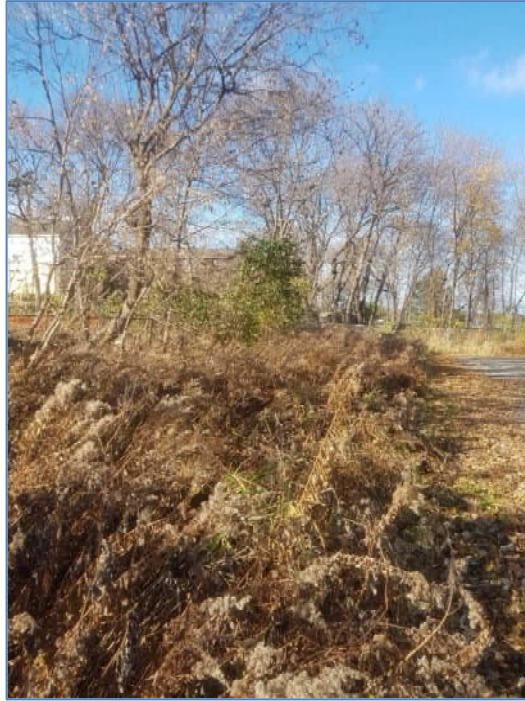
Figure 22: Downstream portion of the third surface drainage feature, facing north; photo taken November 12, 2020.

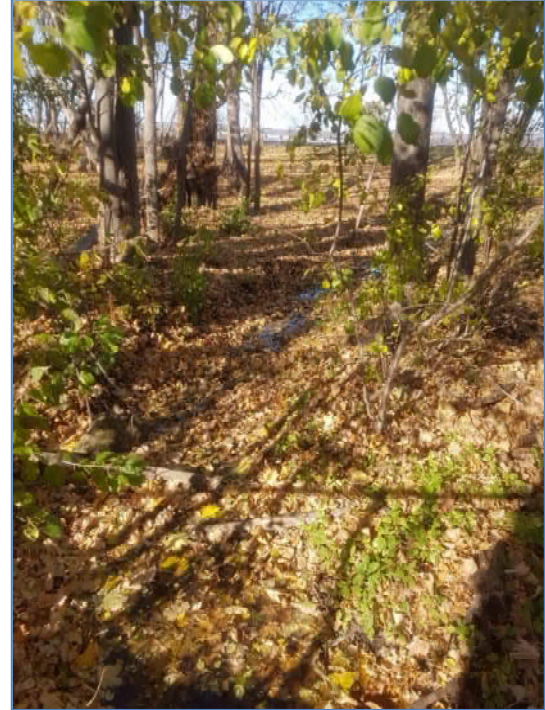
Figure 23: Watercourse on the NCC property north of the property, within a woodlot, facing north; photo taken November 12, 2020.

A third surface drainage (Drainage #3 in **Figure 9**) appears to convey stormwater runoff from adjacent areas through swale that runs from south to north along the west side of the property through a semi-natural area (refer to photos in **Figure 21** and **Figure 22**, **Figure 24** and **Figure 25**). It also exits into the drainage feature on the adjacent NCC property (refer to photo **Figure 23** and **Figure 30**).

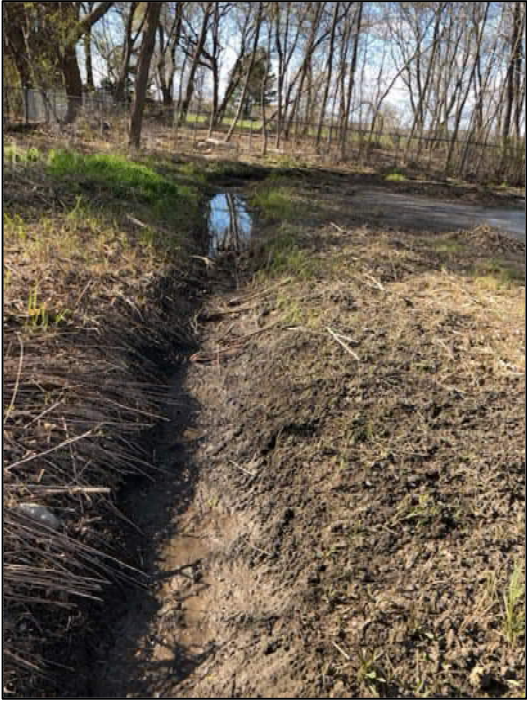
Figure 24: Origin of third drainage feature on the west side of the property, originating from near the River Parkway Childcare Centre; springtime photo supplied by Maryan O'Hagan.

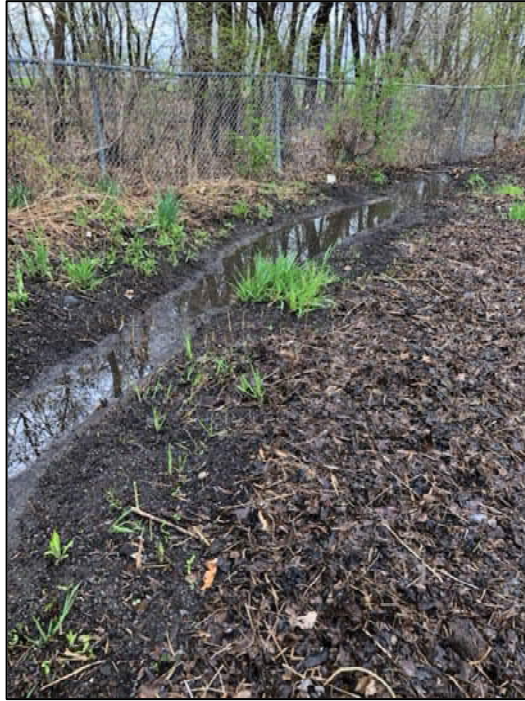
Figure 25: Downstream portion of the third drainage feature, facing north; springtime photo supplied by Maryan O'Hagan.

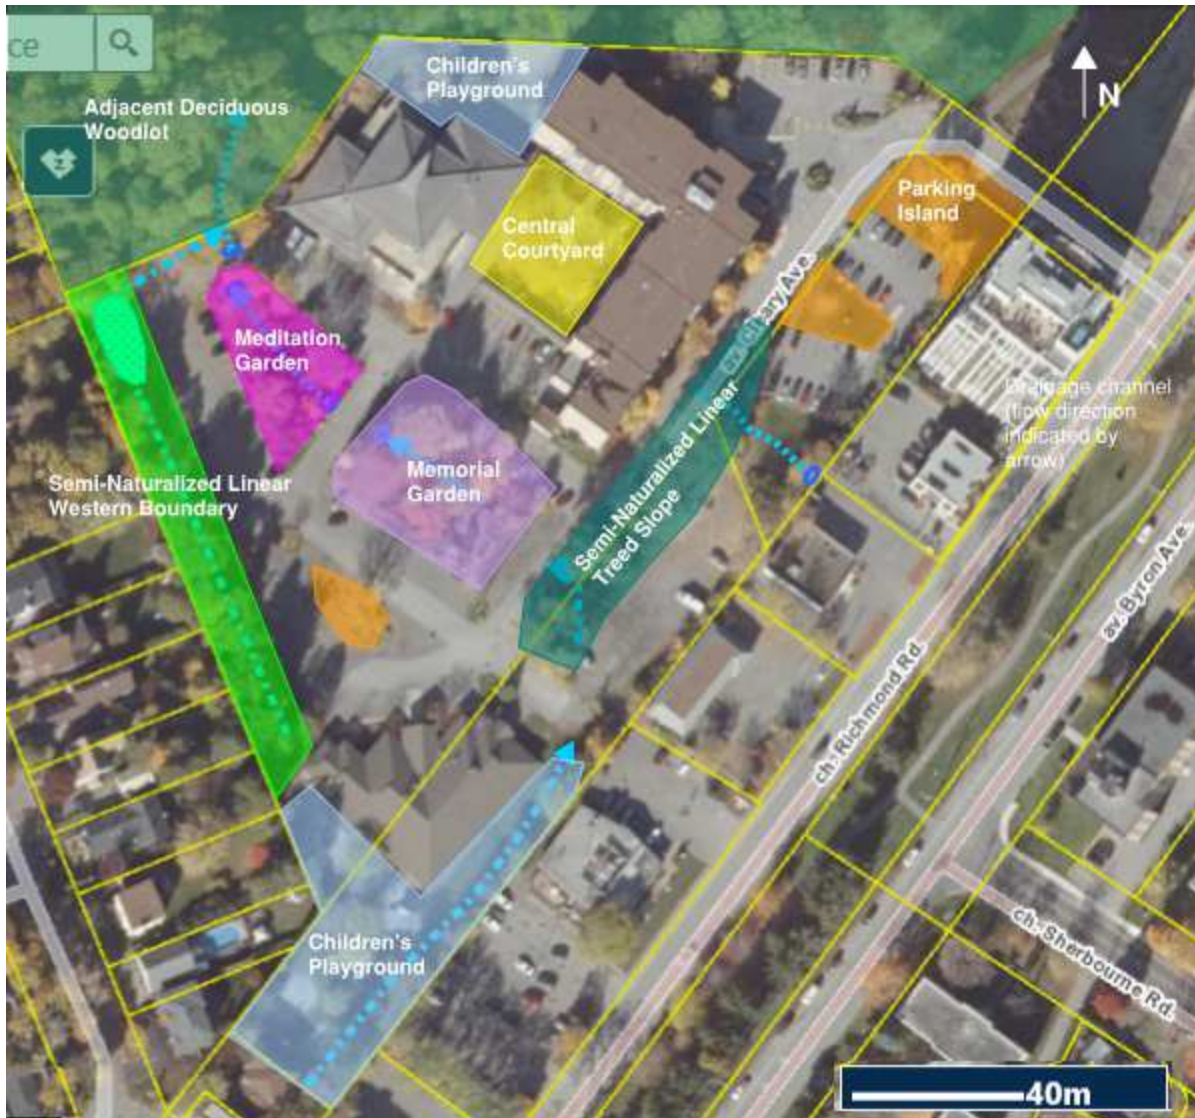
Figure 28: Vegetation Communities on GeoOttawa Image, 2020.

In Ontario, the Ministry of Natural Resources (MNR) defines ecological units on the basis of bedrock, climate (temperature, precipitation), physiography (soils, slope, aspect) and corresponding vegetation, creating an Ecological Land Classification (ELC) system. This classification of the landscape enables planners and ecologists to organize ecological information into logical integrated units to enable landscape planning and monitoring. Using the ELC system, the property would be classified as predominately Constructed Lands, due to the use for the church facility, the daycare, and the senior's residence. As well, the ELC system requires that vegetation communities a minimum of 0.5 ha in size are to be mapped as a community, and as the largest somewhat heterogenous community on the property is 0.1 ha, the ELC system it not appropriate for use in defining these vegetation communities. As this method of classification is not suited to this assessment, the categories that are used in the ELC system are referred to where appropriate, but the vegetation communities are also referred by their purpose or how they are locally known (refer to **Figure 28**).

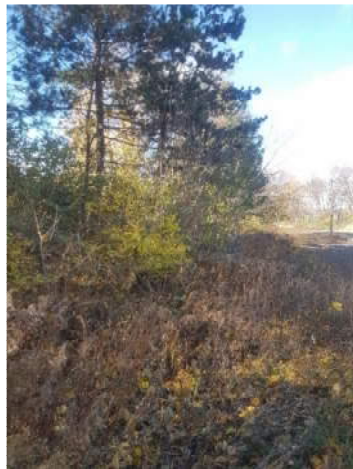
Figure 42: View of treed boundary from near the River Parkway Childcare Centre; photo taken November 12, 2020.

Along the western edge of the property, the vegetation community contains a mix of planted Red Pine (*Pinus resinosa*), self-seeded Manitoba Maples (*Acer negundo*), and a few Wild Grape (*Vitis riparia*) and European Black Alder (*Alnus glutinosa*). It contains a shrub layer of self-seeded Common Buckthorn (*Rhamnus cathartica*) and shrub honeysuckles (comprised of a mix of non-native *Lonicera* sp., including *L. japonica*, *L. maackii*, *L. morrowi*, *L. tatarica*, and *L. xylosteum*) (refer to **Figure 42** and **Figure 43**). The groundcover under the trees is predominately composed of non-native species such as Garlic Mustard (*Alliaria petiolata*), Common Motherwort (*Leonurus cardiaca*), and Creeping Bellflower (*Campanula rapunculoides*). Between the trees and the parking lot, taller herbaceous vegetation is well-established, and is composed of a mix of mostly native and a moderately high level of non-native species. The native species include New England Aster (*Symphyotrichum novae-angliae*), Canada Goldenrod (*Solidago canadensis*), and Jerusalem Artichoke (*Helianthus tuberosus*), which, despite its name, is a species of sunflower native to central North America with an edible tuberous root. It also contains a swale that was partly filled with water at the time of the site visit. The swale is bordered by the small wetland area (discussed in **Section 2.6**), which contains a mix of Cattails (*Typha* sp.), European Common Reed (*Phragmites australis* ssp. *australis*), and Reed Canary Grass (*Phalaris arundinacea*).

The community is about 1,300 m² in size, and averages approximately 12 m in width, and is 100 m long. It has historically been heavily disturbed, contains what appears to be a mix of broken concrete fill in the location where a former access lane came through from Aylen Avenue, and does not contain any trees that existed prior to 1958 based on the aerial imagery on GeoOttawa. Despite the lack of native plants within the treed portion, it provides ecological value by simply providing cover, protection, and foraging opportunities for wildlife, including insects. The presence of the wetland and water is of importance to many species (discussed in **Section 2.6**). It also creates a contiguous canopy of trees with the adjacent Deciduous Woodlot (discussed above in **Section 2.7.1**), providing a movement corridor for birds that prefer to stay under cover as they move through the landscape.

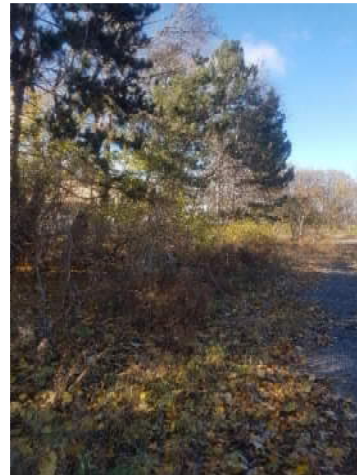
Figure 43: Treed boundary near the old lane from Aylen Avenue; photo taken November 12, 2020.

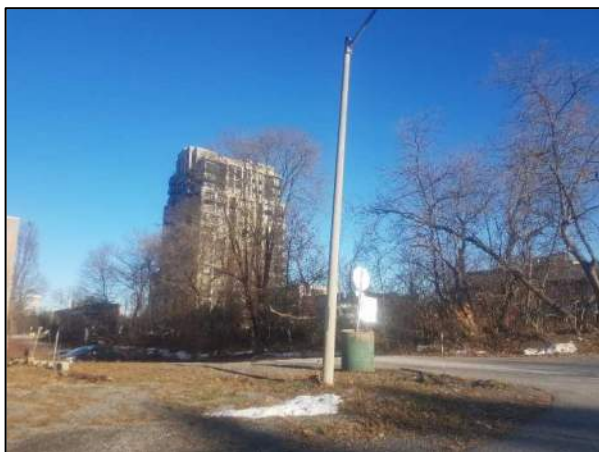
Figure 46: View of treed slope; photo taken November 12, 2020.

Running generally east to west and immediately north of the old rail line, a treed slope follows the entrance lane that exists at the end of Cleary Avenue (refer to **Figure 46** and **Figure 47**). Two (2) drainage features flow down this slope (discussed in **Section 2.5**). It also contains a rock garden which is maintained by residents. It is approximately 12 m wide, 90 m long, and is 1,100 m² in size. It appears to contain some trees which may have been present since 1958, however has had some history of disturbance due to clearing for parking lots on the upper part of the slope, i.e. on the old rail line.

The tree species on the slope are a mix of native Eastern White Pine (*Pinus strobus*), small spruce (*Picea* sp.), Manitoba Maple, Crabapple (*Malus* sp.), and other deciduous species. It contains a moderately dense understory of and regenerating trees (comprised of the same species at the overstory) and shrubs. The shrub species are comprised of the same species that can be found on the semi-naturalized linear western boundary area (discussed above in **Section 2.7.3**), as well as Staghorn Sumac (*Rhus typhina*). The groundcovers are also similar to those found under the trees in the western boundary area. Similar to the western boundary area, the understory and groundcover are a testament to the legacy of disturbance.

This area is ecologically isolated from other treed areas, but nevertheless, the vegetation plays an important role in stabilizing the soil on the slope and purifying the water that runs over the slope. Trees create a large canopy that disperses the force of rain, and captures precipitation, allowing it to trickle slowly off the leaves and branches so it does not wash out soil and vegetation downstream. The shade and beauty provided by these trees is also undoubtedly invaluable to the residents of the Unitarian House and the congregants of the First Unitarian Church.

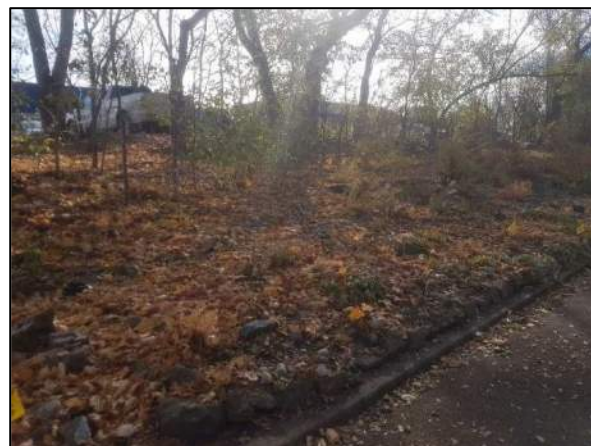
Figure 47: Rock Garden within the treed slope; photo taken November 12, 2020.

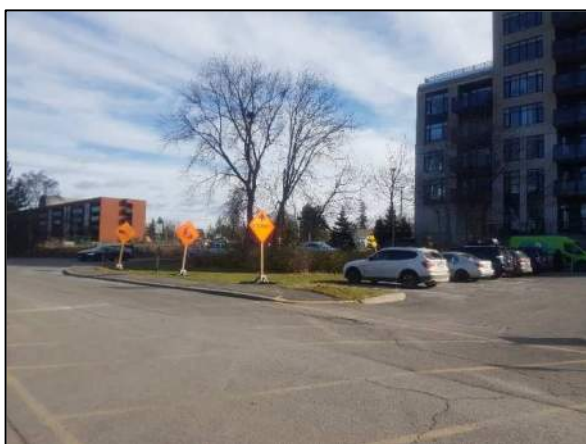
Figure 48: Island near entrance with trees, shrubs, and lawn; photo taken November 12, 2020.

There are several small islands of vegetation interspersed within the parking lot areas (refer to example in **Figure 48**). Most contain one (1) to a few trees, lawn, and some have shrubs as an understory to the trees. A few small islands in front of the Unitarian House contain landscape plants and shrubs (refer to **Figure 49**). One of the islands which is located between the two (2) paved parking lots on the old rail line area (at 25 Cleary Avenue) used to be treed in 2005, but the trees were removed in 2011 and a remaining tree in 2014. Due to their small size, they play a very minor role in their ecological importance for wildlife, but do provide a surface that allows precipitation to infiltrate into the soil, trees to cool the air and soil, and visual interest. As well, the graveled parking lots allow water to infiltrate into the soil, and do not exacerbate stormwater runoff to the same extent that harder surfaces such as roofs, asphalt, and concrete do.

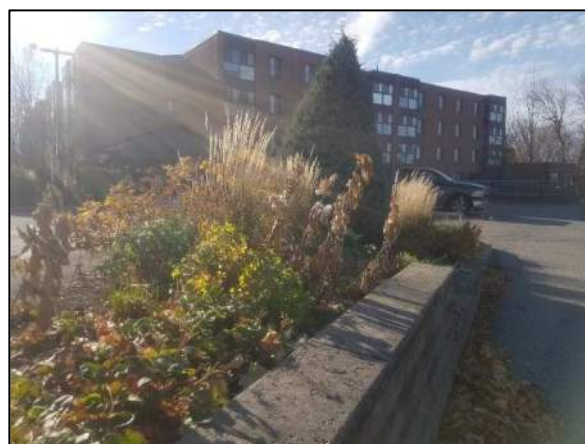
Figure 49: Small landscaped garden within parking island containing a mix of non-native and native herbaceous plant species; photo taken November 12, 2020.

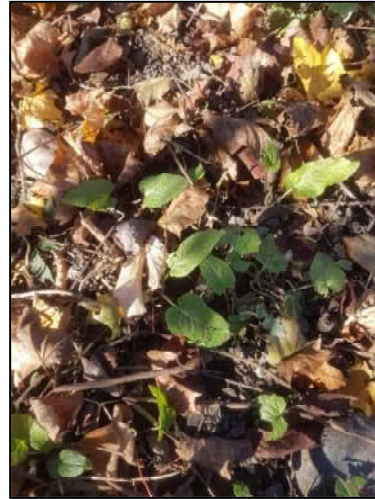
Figure 62: Creeping Bellflower plants without flowering stems growing in the semi-naturalized linear western boundary and by adjacent deciduous woodlot ; photo taken November 12, 2020.

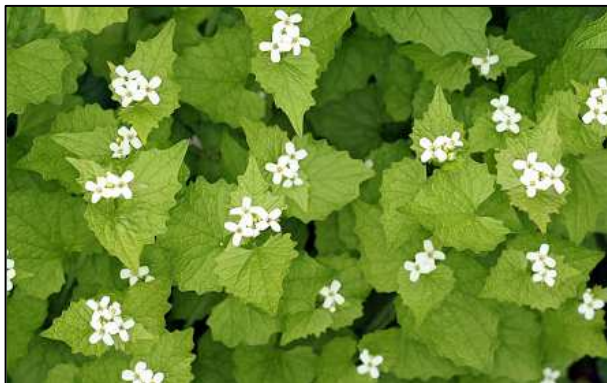
Figure 63: Flowers of Garlic Mustard; photo taken from Google.

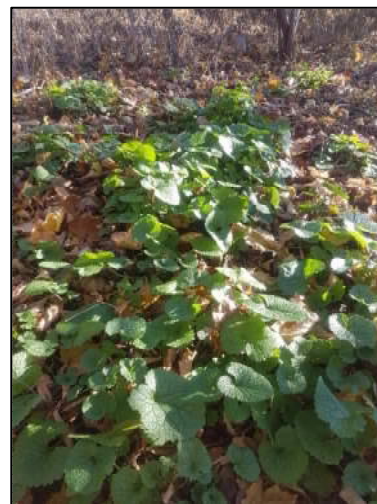
Figure 64: Garlic Mustard plants without flowering stems growing in the semi-naturalized linear western boundary and by adjacent deciduous woodlot; photo taken November 12, 2020.

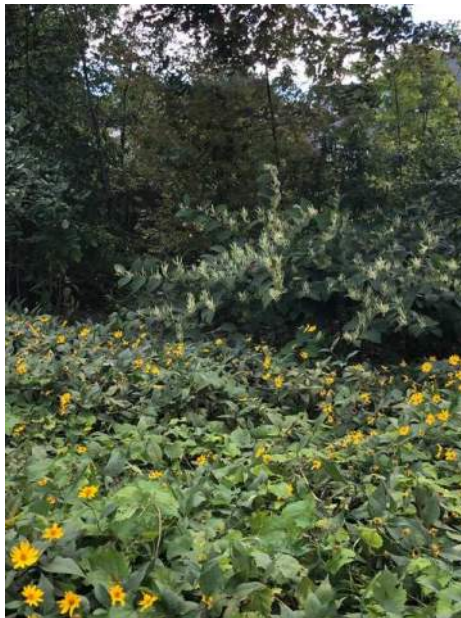
Figure 67: Japanese Knotweed growing in the semi-naturalized linear western boundary and by adjacent deciduous woodlot; photo provided by Maryan O'Hagan.

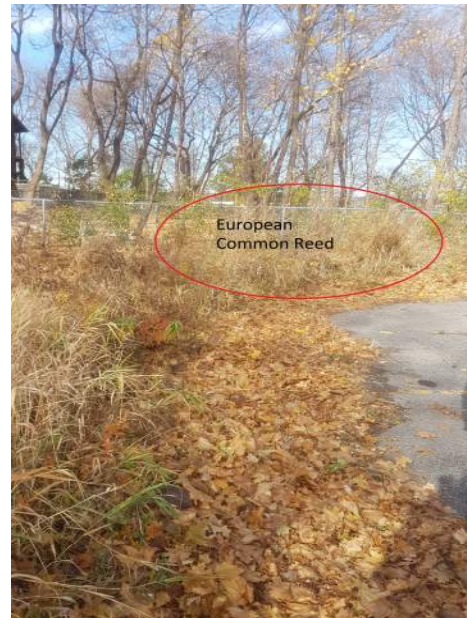
Figure 68: European Common Reed growing by adjacent deciduous woodlot on the NCC lands; photo taken November 12, 2020.

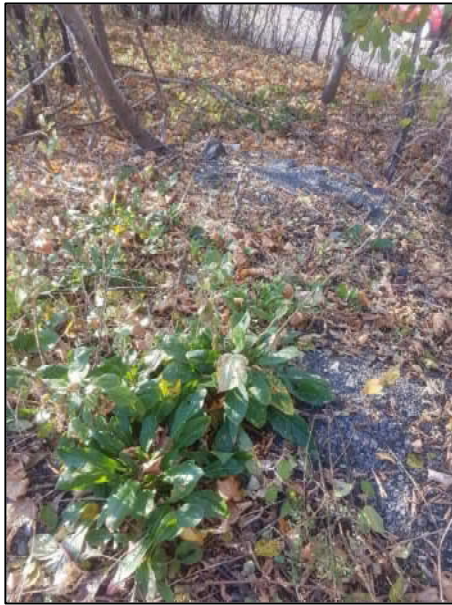
Figure 69: Dame's Rocket growing in the semi-naturalized linear western boundary in concrete rubble fill area; photo taken November 12, 2020.

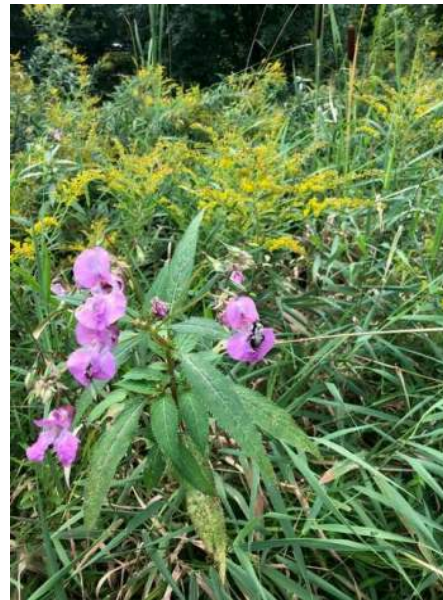
Figure 70: Himalayan Balsam flowering stems growing in the semi-naturalized linear western boundary and by adjacent deciduous woodlot; photo provided by Maryan O'Hagan.

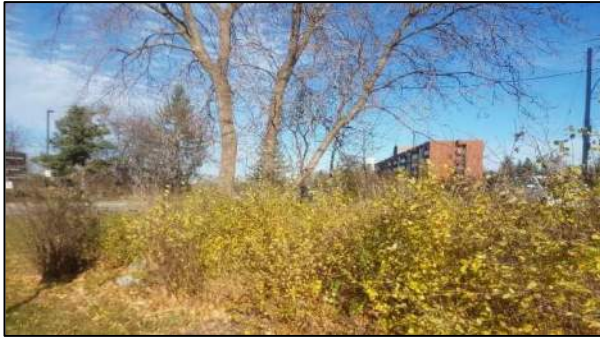
Figure 73: Shrub Honeysuckle growing in semi-naturalized linear western boundary; photo taken November 12, 2020.

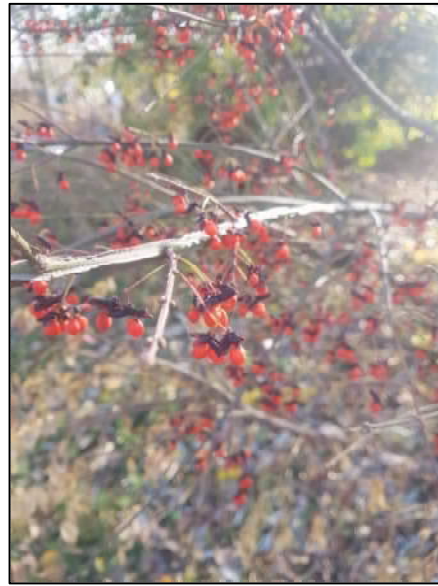
Figure 74: Japanese Barberry growing in fenceline between the north side of the church and the NCC property; photo taken November 12, 2020.

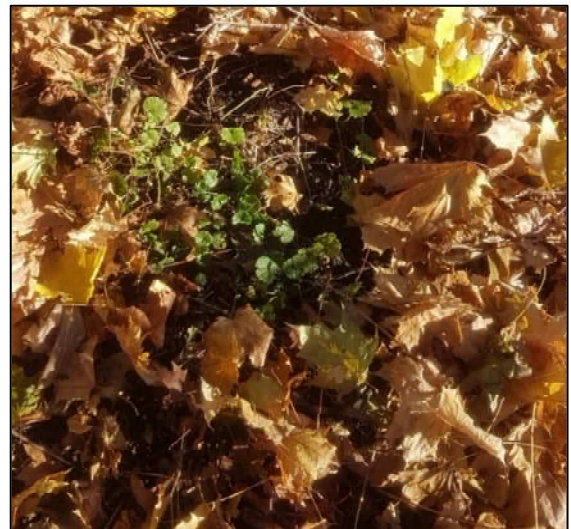
Figure 76: Creeping Charlie without flowering stems growing in parking lot areas along the upstream area of drainage #1; photo taken November 12, 2020.

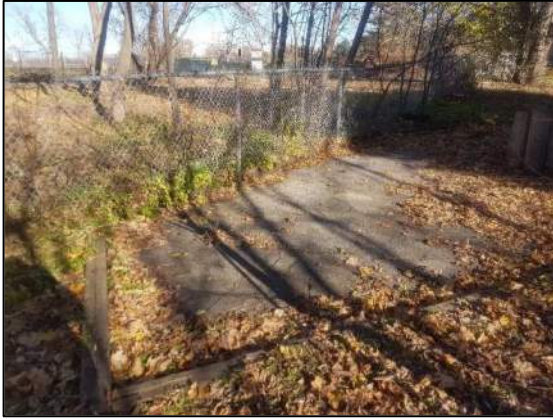
Figure 77: Pavement near NCC lands; photo taken November 12, 2020.

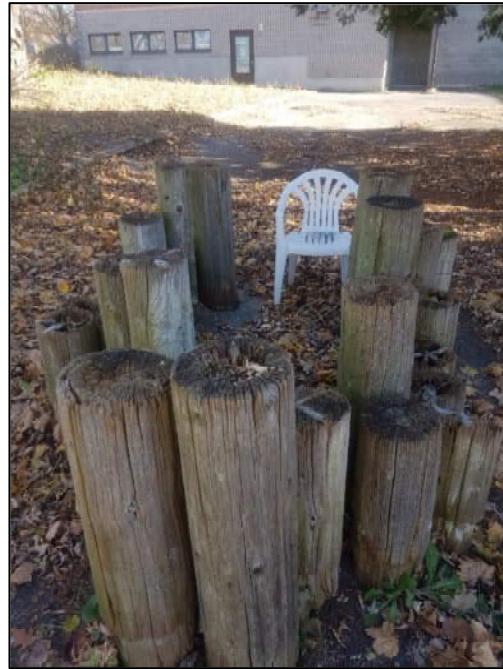
Figure 78: Pavement near NCC property; photo taken November 12, 2020.

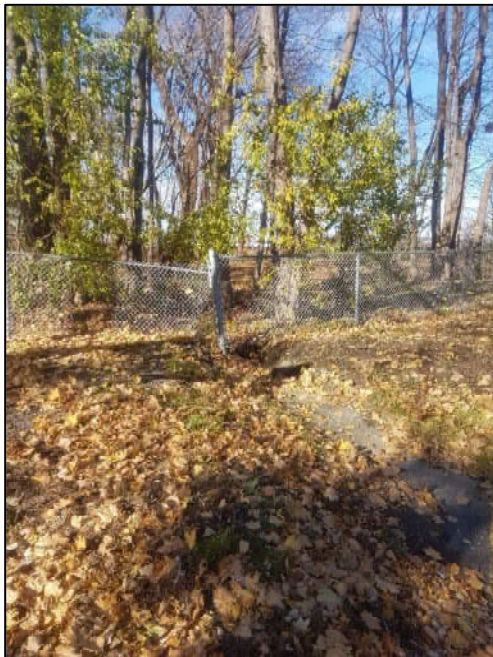
Figure 79: Paved drainage feature, for conveying stormwater from parking lot; photo taken November 12, 2020.

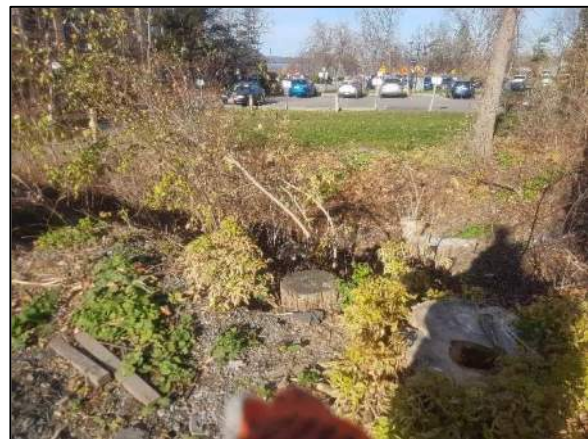
Figure 80: Recently removed trees along Drainage #1; photo taken November 12, 2020.

- Return watercourses and drainage to a more natural configuration with sinuosity and pools, and by restoring natural cover (refer to **Figure 80** for an example of area requiring more natural configuration and vegetation, and to **Figure 101, #1** for other areas where this is proposed). The work that was completed on the watercourse running through the Memorial and Meditation garden is an example of a more natural configuration, and the same principles can be applied to the drainages within the property. For example, the lawn around Drainage #2 can be replaced with a diversity of plants suited to the fluctuating soil moisture conditions.

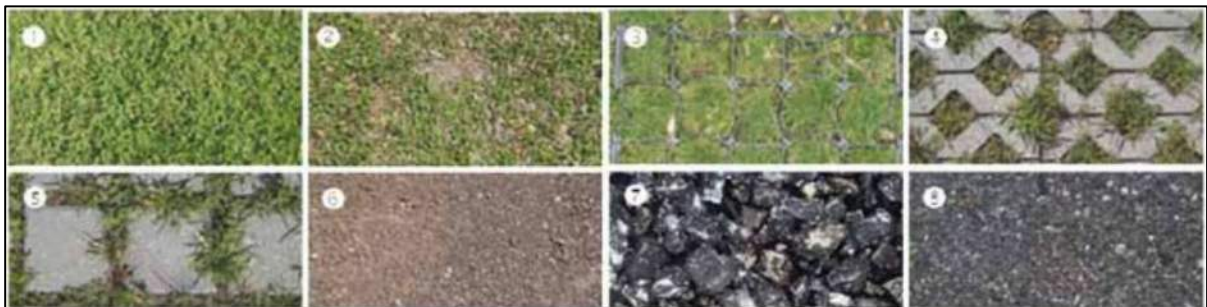
Figure 82: Overview of most common ground surfaces, from most to least permeable (European Union, 2013)

- Where possible eliminate paved surfaces—on walkways use gravel or wood chips (refer to **Figure 82** for examples of surface treatments, from most to least permeable).

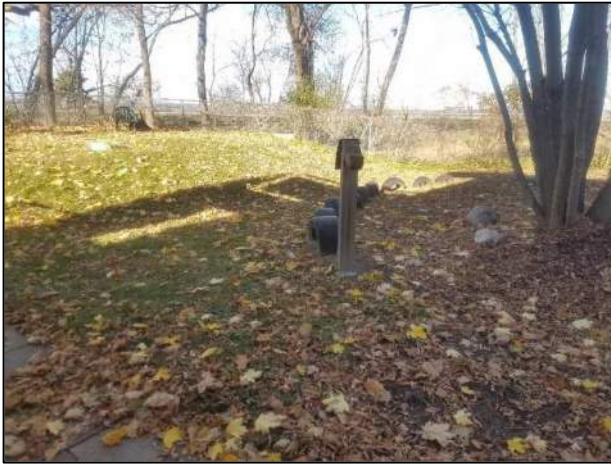
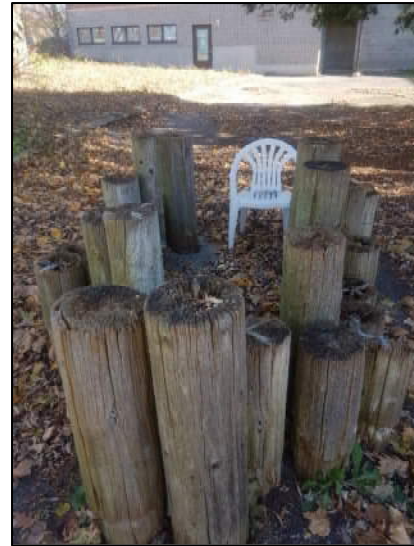
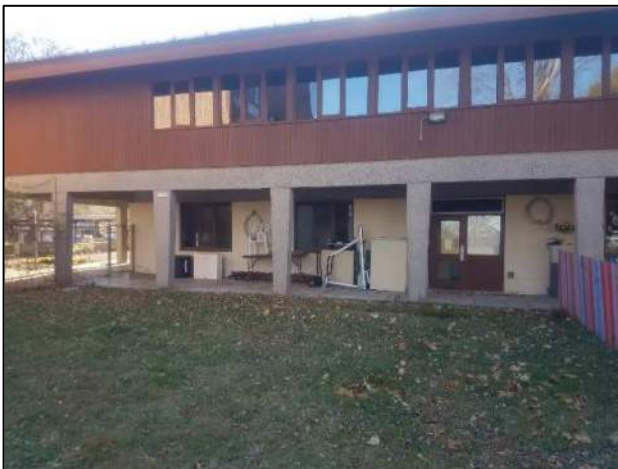
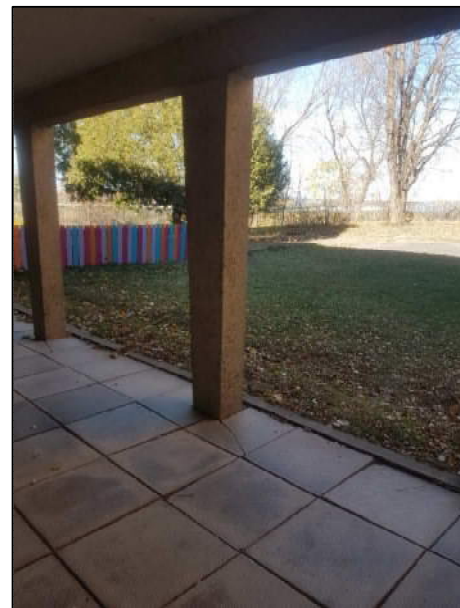
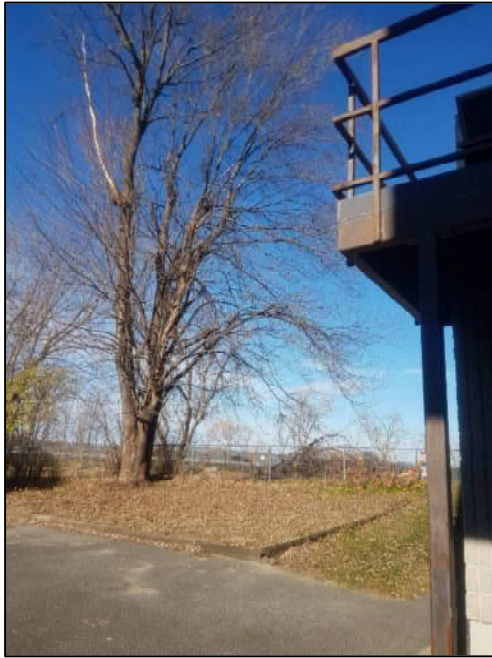
Figure 83: Lawn area north of the church adjacent to the NCC lands; photo taken November 12, 2020.

Figure 84: Pavement and lawn north of the church near NCC property; photo taken November 12, 2020.

Figure 85: Lawn area north of the church; photo taken November 12, 2020.

Figure 86: View of lawn area from lower church level; photo taken November 12, 2020.

Figure 87: Pavement and lawn north of the church near NCC lands; photo taken November 12, 2020.

In addition to increasing the size of the woodlot by removing parking area, additional woodland buffer can be instated along the northern side of the church (refer to **Figure 83** to **Figure 87**, and to **Figure 101**, #2 for other areas where this is proposed), where lawn currently exists. While access to these areas could and should be maintained by either creating a path or leaving a groundcover that is resilient to traffic, these areas appear to be maintained as relatively large lawn areas with no purpose other than to cover ground. If they are underused and lawn in these areas is not strictly necessary, but the congregation wishes to maintain views towards the river, it is recommended that a lower mixed-height canopy of trees is established (by selecting trees with a lower mature height, such as Blue Beech, *Carpinus carolina*; refer to **Appendix A** for sources for additional species) to maintain some open view from the church windows while still providing a buffer for and expanding the woodland.

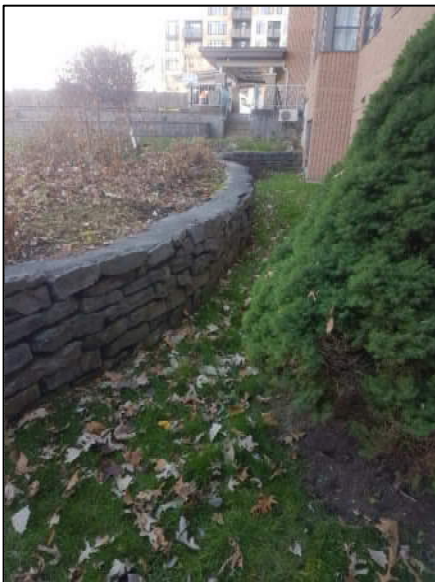
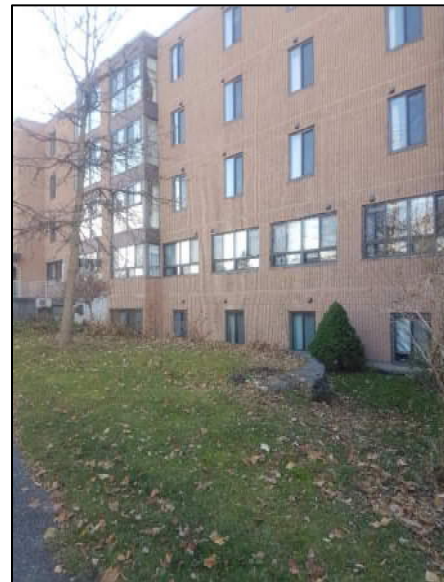
Figure 89: Lawn area beside Unitarian House that can be converted to Food and Healing gardens; photo taken November 12, 2020.

Figure 90: Lawn area beside Unitarian House that can be converted to Food and Healing gardens; photo taken November 12, 2020.

Along the northwest side of the property, an area of lawn with a pathway can be converted to an additional "Healing Garden" (also under the direction of the Algonquin Anishinabeg) or combined with a Food Garden (which is in itself healing and medicinal), potentially including plants that are considered medicinal in 'western' culture (although a lot of these plants will be non-native, not all are invasive). Pollinator plants would also do well in this area, mixed in for colour and interest (refer to **Figure 88** to **Figure 90**, and to **Figure 101**, #4 for other areas where this is proposed).

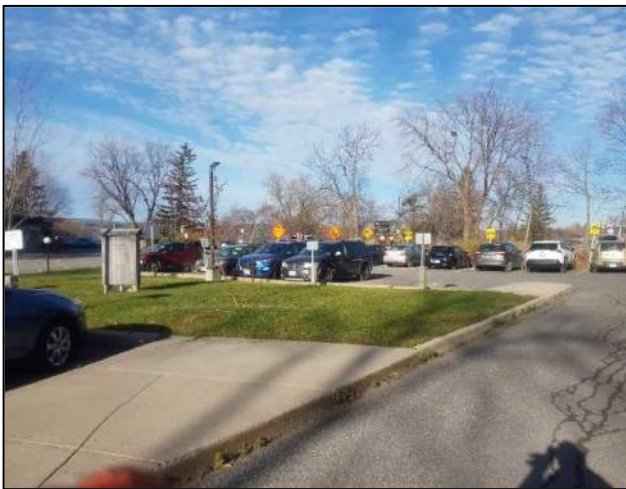
Figure 93: Lawn area near Unitarian House parking lot that can be reforested; photo taken November 12, 2020.

Towards the south end of the property, areas of lawn surrounding the parking lots have been either slowly overtaken by invasive shrubs or have lost tree cover over time. As well, there is an excess of lawns along the south end of the Unitarian House and around the River Parkway Childcare Centre. These areas would provide more beauty, wind protection, shade, and ecological benefits if planted with native trees, shrubs, grasses and herbaceous plants, including pollinator and wildlife 'friendly' species (refer to **Figure 92** and **Figure 93**, and to **Figure 101**, #5 for other areas where this is proposed). In areas where snow storage must be maintained during the winter, lower-growing plants can replace the lawn. While these plants establish themselves, undyed shredded bark or other organic mulch should be applied, and reapplied as necessary to maintain a 5 to 8 cm depth of mulch.

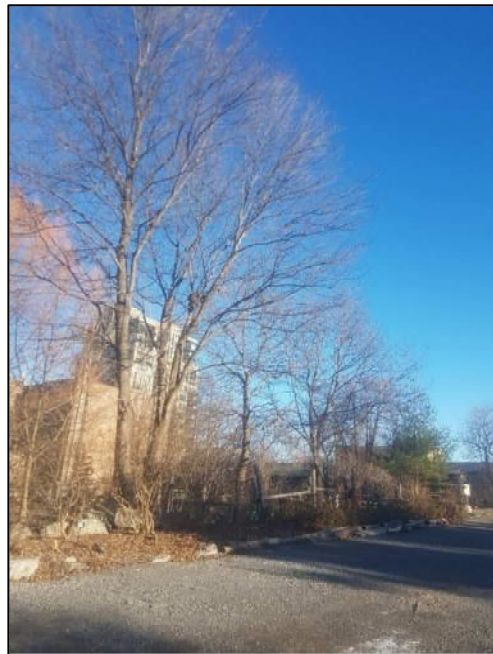
Figure 94: Tree slope north of Cleary Avenue Lane that can be reforested; photo taken November 12, 2020.

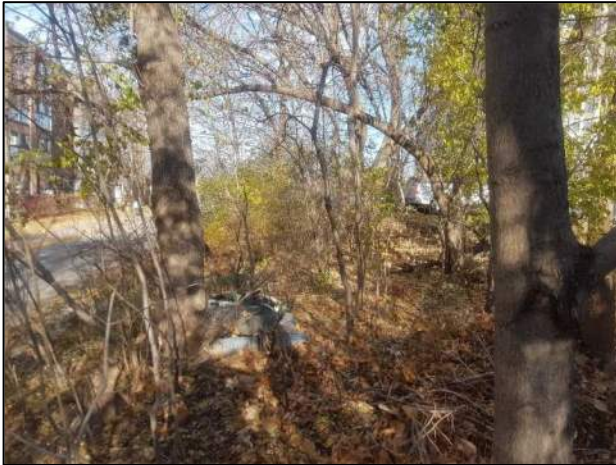
Figure 95: Treed slope north of Cleary Avenue Lane where invasive species can be replaced; photo taken November 12, 2020.

Along the west side of the property and on the slope south of the Cleary Avenue entrance lane, the treed areas have developed a moderate to heavy understory of invasive trees, shrubs and other plants. These can be removed and replaced with a mix of native and non-invasive plants trees, shrubs and other plants (refer to **Figure 94** to **Figure 97**, and to **Figure 101**, #3 for other areas where this is proposed). By removing these invasive species, it will reduce the source of seeds and propagules¹¹ that may infiltrate other areas, while improving food sources for visiting wildlife. The invasive Common Buckthorn and others like shrub honeysuckles produce a berry that is eaten by birds, but provide a lower nutritional value than the fruit from native species that are displaced. Birds must then spend more time and energy searching for non-native berries to fuel themselves and their young. As well, Common Buckthorn in particular is known for producing a secondary metabolite called emodin that produced deformation and mortality on early developing larvae (i.e. tadpoles and efts¹²) of some amphibian species (Sacerdote-Velat, 2014; Lincoln Park Zoo, 2013). These exudates can travel in water to the river, harming wildlife offsite. As an example of preferred species, the native Serviceberry shrubs that are planted near the Unitarian House entrance and around the Courtyard undoubtedly used by local birds and wildlife.

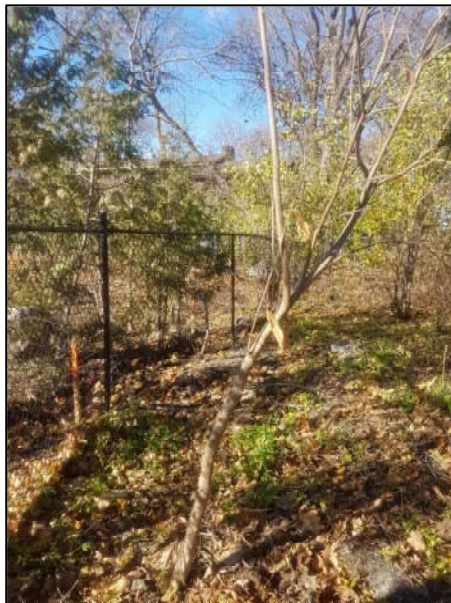
Figure 97: Treed western boundary where invasive species can be replaced and concrete rubble can be removed; photo taken November 12, 2020.

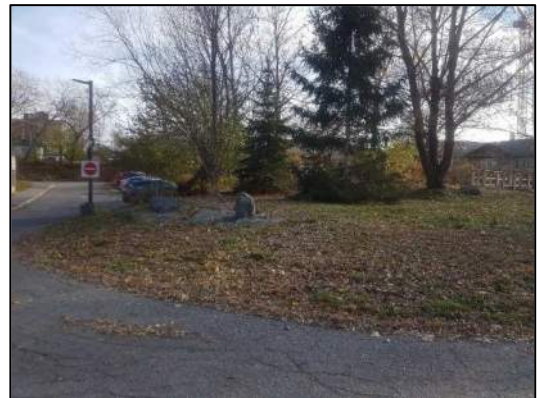
Figure 98: Pavement and lawn near NCC property that can be taken up and reforested; photo taken November 12, 2020.
