FINAL REPORT

Ecological Asset Review

First Unitarian Church

Report No. 1 2100557.ON

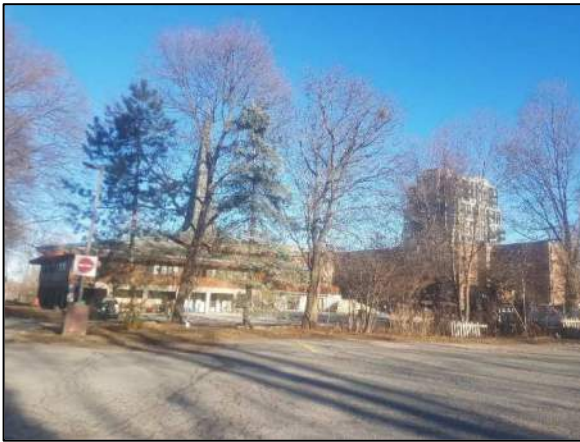
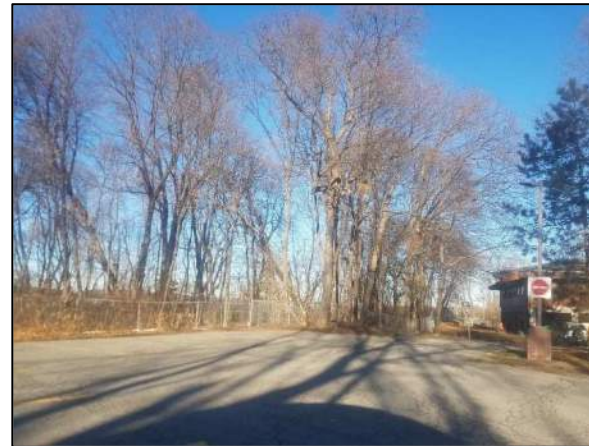
Figure 99: Pavement and lawn near NCC property that can be taken up and reforested; photo taken November 12, 2020.

Figure 100: Pavement near NCC property that can be taken up and reforested; photo taken November 12, 2020.

There is an opportunity to achieve multiple and compounding ecological improvements by carrying out one major effort - increasing the size of the woodlot on the adjacent NCC property by removing parking area and restoring it to woodland (refer to **Figure 98**, **Figure 99**, **Figure 100**, and to **Figure 101**, #2 for other areas where this is proposed). In the case of woodlands, bigger is better. Although this would be a long-term effort, as woodlots mature slowly, it would be an incredible legacy for future generations and a learning opportunity for residents, children who attend the care centres, congregants, and guests.

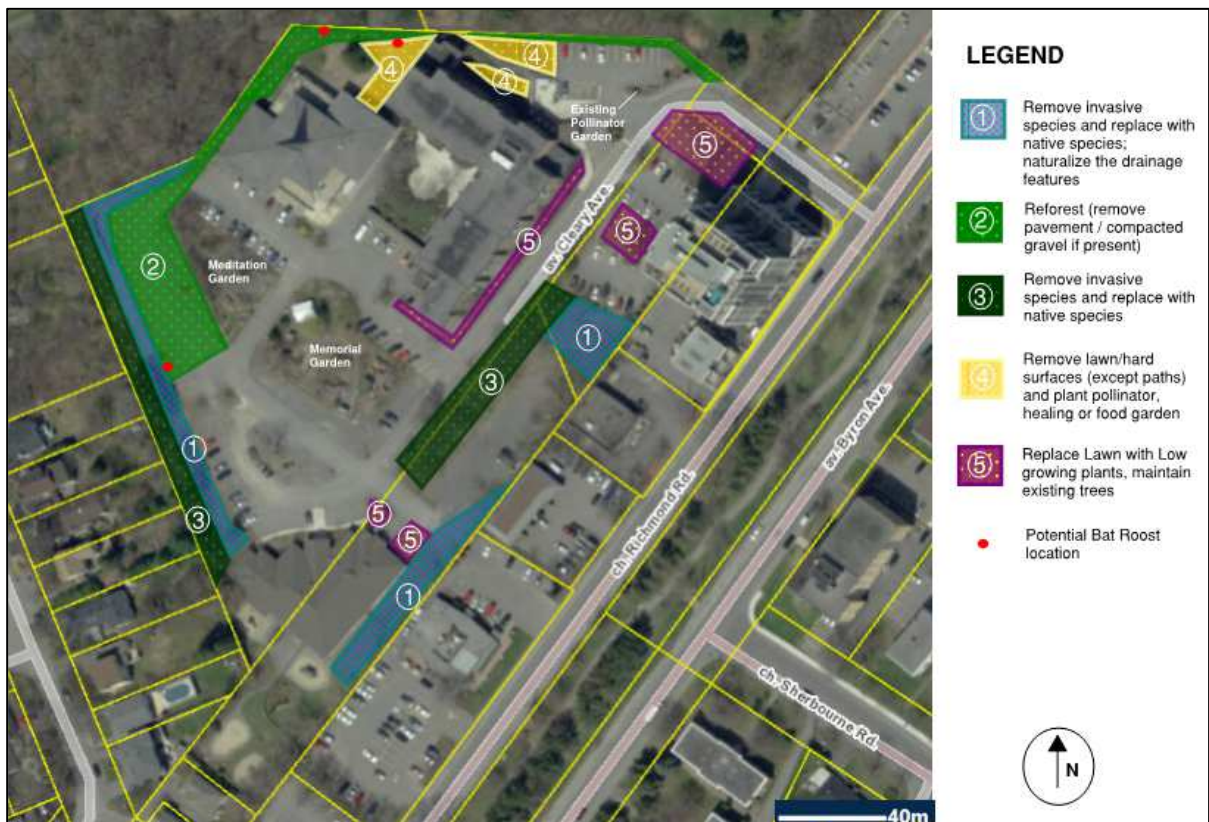
Figure 101: Overall Ecological Restoration and Augmentation Recommendations; aerial image from GeoOttawa.

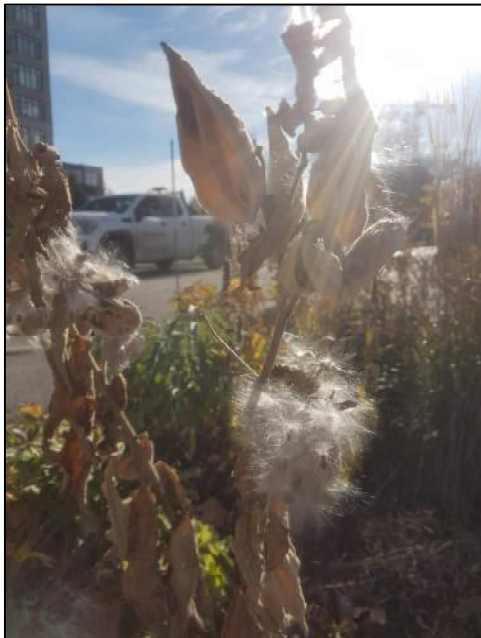
Figure 102: Common Milkweed plant in existing pollinator garden adjacent to the Unitarian House parking lot; photo taken November 12, 2020.

To create additional habitat for Monarch, Common Milkweed (refer to **Figure 102**), Swamp Milkweed, and Butterfly Milkweed should all be seeded or planted in the property. Seeds should be locally sourced where possible, to ensure genetic suitability to the site conditions. These will support larval stages of Monarch. Adults can be supported by the seeding of nectar bearing species such as those noted in **Appendix B** (refer to **Figure 103**). By enhancing insect populations, they in turn pollinate and enhance plant diversity and reproduction and become a food source for birds and other wildlife.

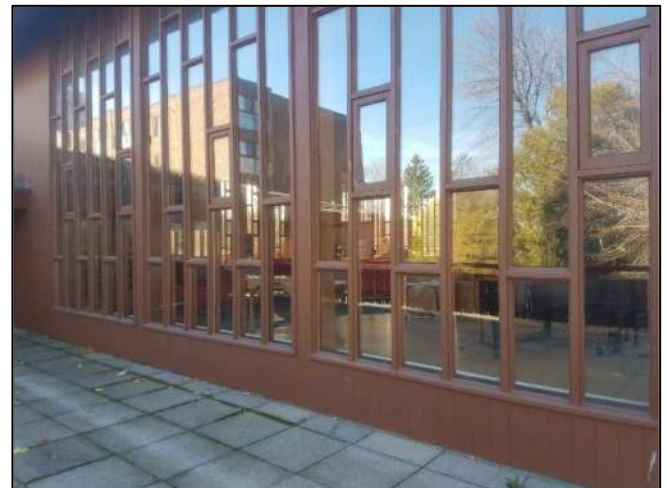
Figure 104: Large windows require bird protection measures; photo taken November 12, 2020.

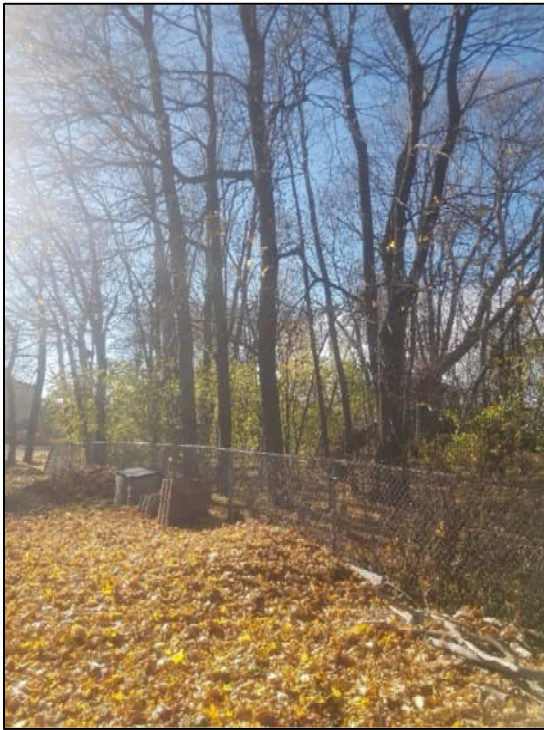
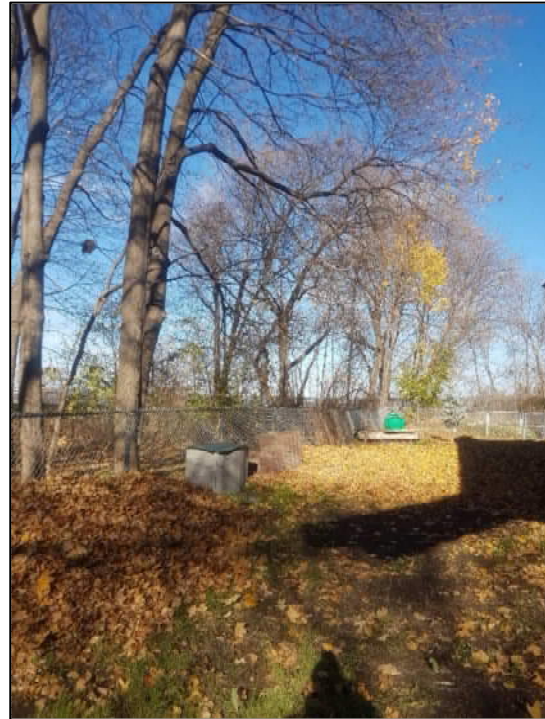
Figure 106: One of the potential general locations for Bat house installation, north of the church near the NCC woodlot; photo taken November 12, 2020.

Figure 107: Another potential general location for a Bat house installation, north of the church near the NCC woodlot; photo taken November 12, 2020.

The structures should be placed above the highest surrounding vegetation in order to receive 6 to 8 hours of sunlight, and should be placed facing south to receive maximum available sunlight (BCI, 2017; Toronto Zoo, 2017). White-nose syndrome affected bats were much more likely to use heated bat houses and modelling predicted energy-savings of ~80% (Wilcox and Willis, 2016), indicating that roost temperature is critical for best solar heating, and overall improves success for White-nose syndrome affected bats rearing young. Warm roost microclimates could also enhance recovery from White-nose syndrome (Wilcox and Willis, 2016).
